## 5.7 Access, Circulation and Connections

## 5.9 Existing Hydrology and Lakes

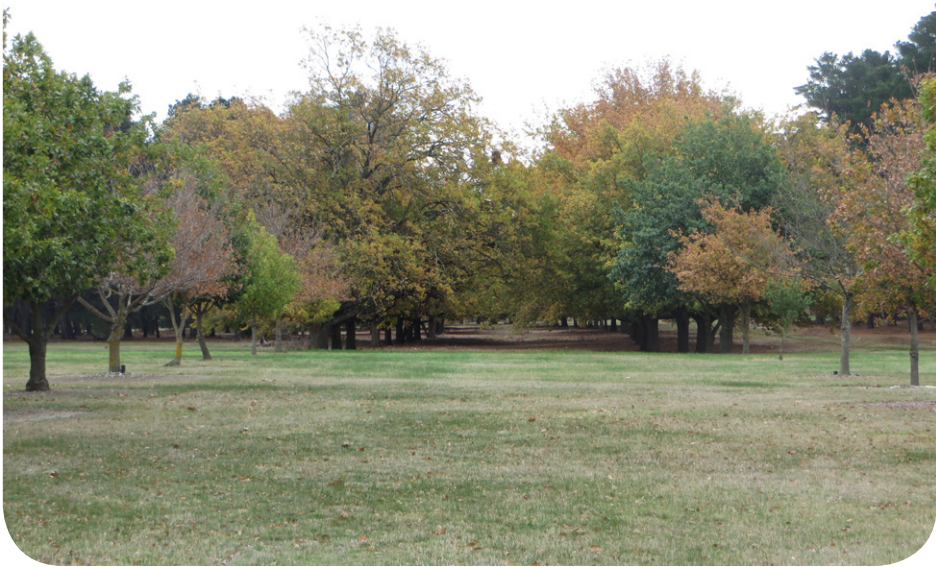
*South east corner - no path*

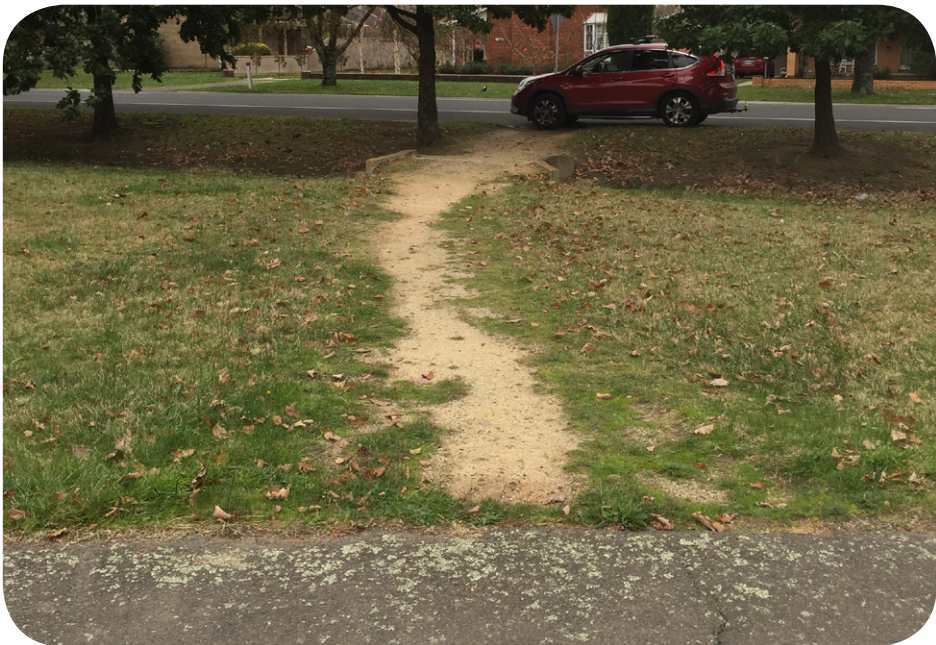
*Goat track connection to Russell St*

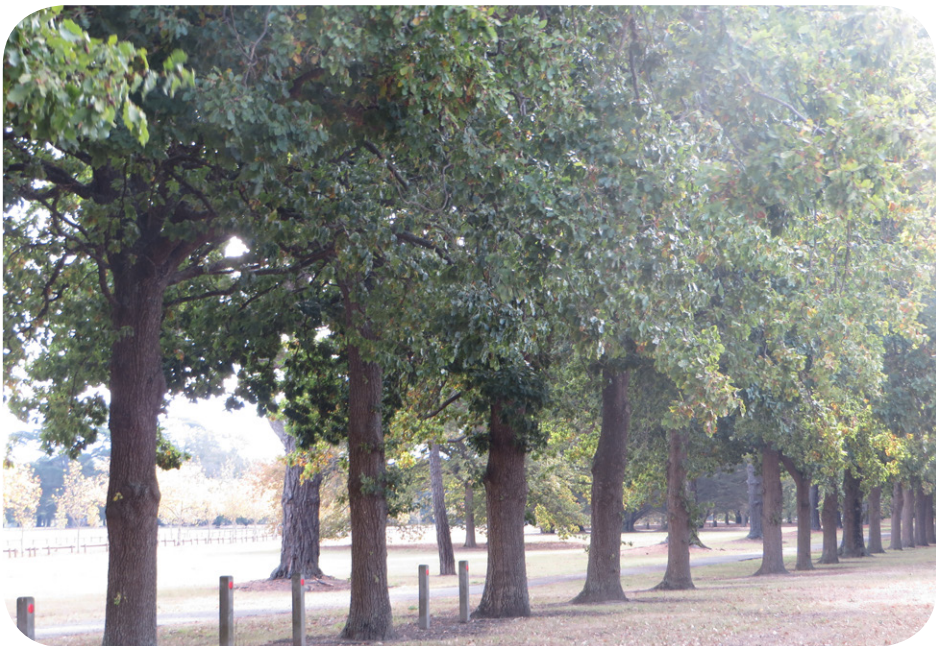
*Permeable boundary to Russell St*

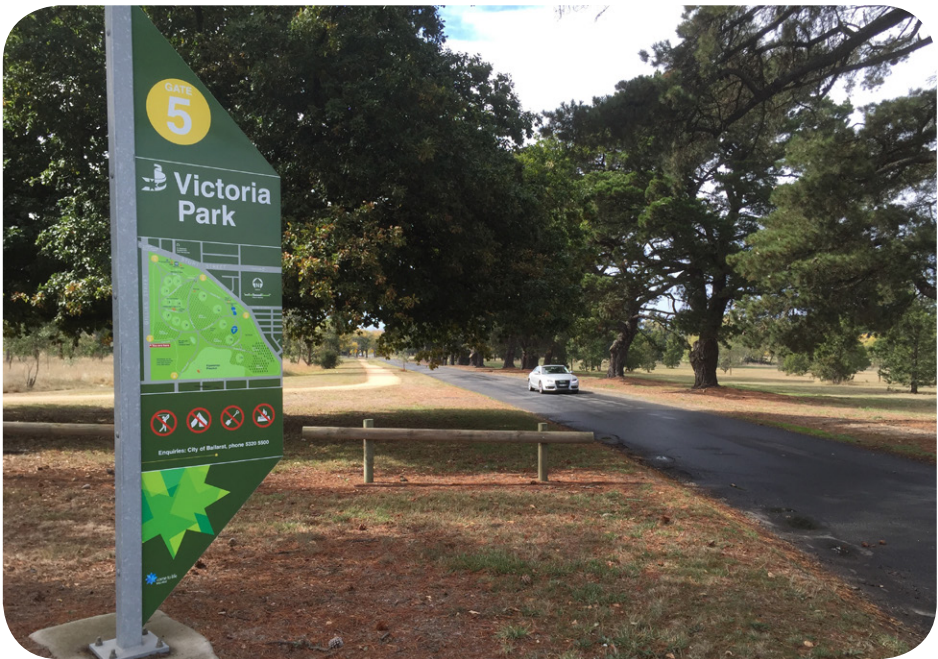
At each vehicle entrance, a park entry sign exists which sufficiently details where you are in relation to the Park, what the Park has to offer and local laws. They are large and, generally, set back from the road enough to allow cars to pull up beside them. In some instances, footings are exposed but otherwise they are in good condition.

Existing park entry sign

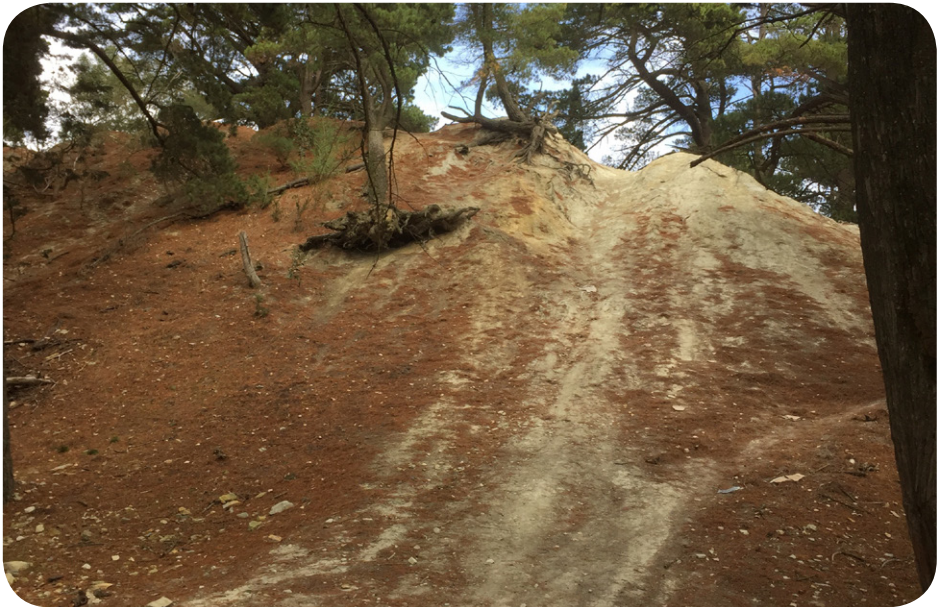
Mt Holled Smith currently has no interpretative signage

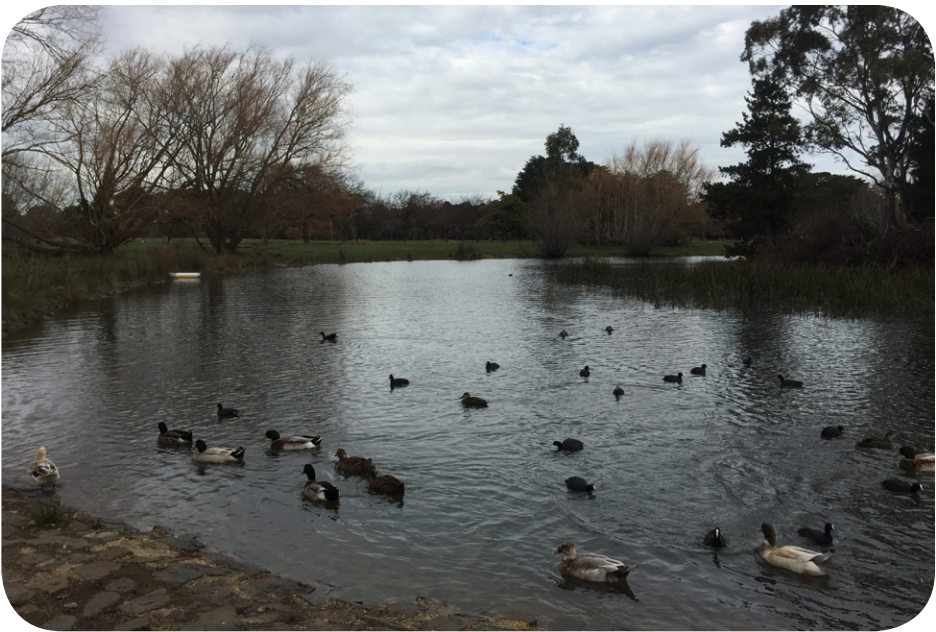
The southern lake (Lake 2) has a bluestone pitcher edge along its eastern edge, installed to prevent erosion at the lakes edge. It presents as hard and methods of suring up the lakes edges using more natural methods should be explored. This lake has a diversity of tree types and a central island that is dense with vegetation. The northern edge of this lake is flanked by an uneven gravel car park which allows cars to pull up on the waters edge.

Existing Lake 2

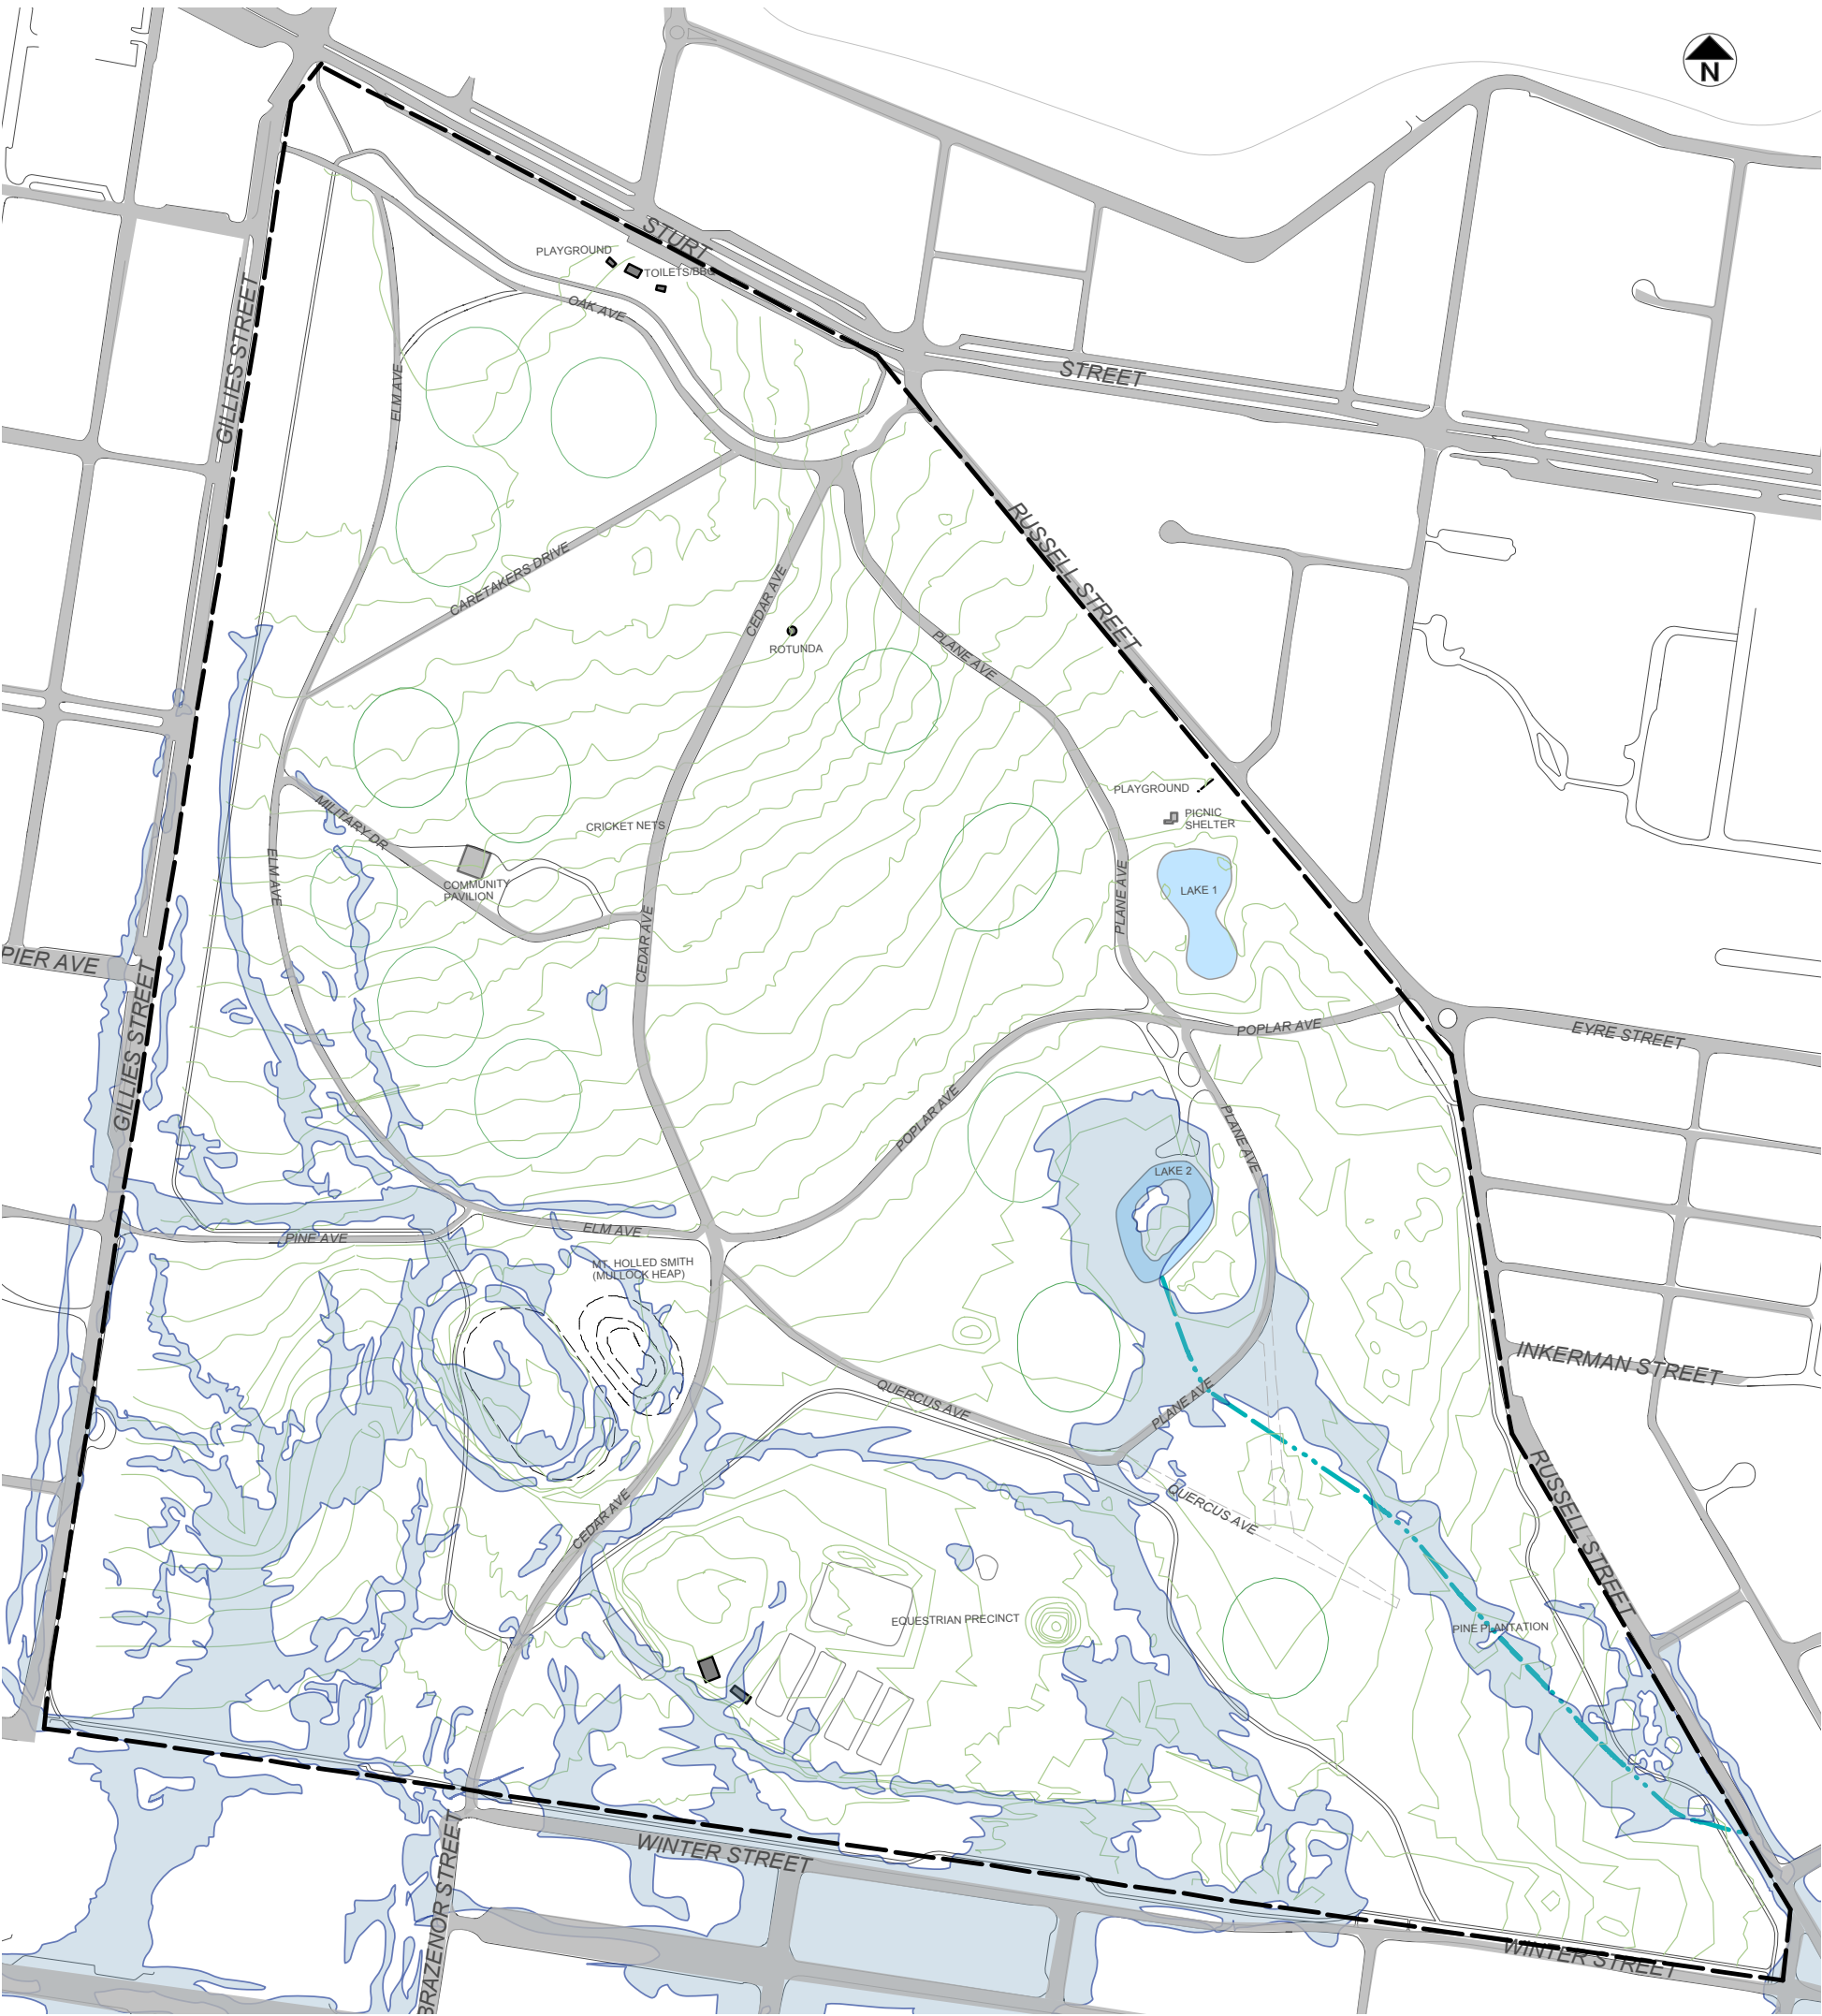
Existing Hydrology and Lakes Plan

Southern areas of the Park are prone to localised flooding in wet weather as reflected in the flood mapping report, Bonshaw Creek Flood Study prepared by Engeny in March 2013. The areas most affected are Plane Avenue around Lake 2 and the Winter Street edge, though the whole Park is prone to surface ponding during heavy downpours and prolonged rainfall.

Generally, the Park drains to the south. While the west side of the Park drains across land toward the south-east, the east side of the Park drains through a system of open grassed swales that direct water into the lakes. St Leger Pond picks up untreated storm water from the surrounding residential catchment. This overflows to the southern lake, which picks up two additional inflows from St Patricks College and from a small area of the Park to the south. The overflow then drains through an open swale to the south-east corner at Russell Street. The system does not currently have capacity to deal with flood events resulting in flooding near the southern lake.

There is potential to increase the capacity of the existing lakes and for multiple new wetlands in the lakes precinct and along the southern and south-eastern edge. This would assist in improving water storage, water quality and habitat, bio-diversity, and reduce localised flooding throughout the park and along its roads. Water quality could be further improved with modifications to swales and increased swale planting.
